ALTA ENGINEERING, Ltd.
CONSULTING ENGINEERS

October 4, 2023

Re: 716 N. Dunton - Existing conditions
Arlington Heights, IL
AEL No. 23514.AEL

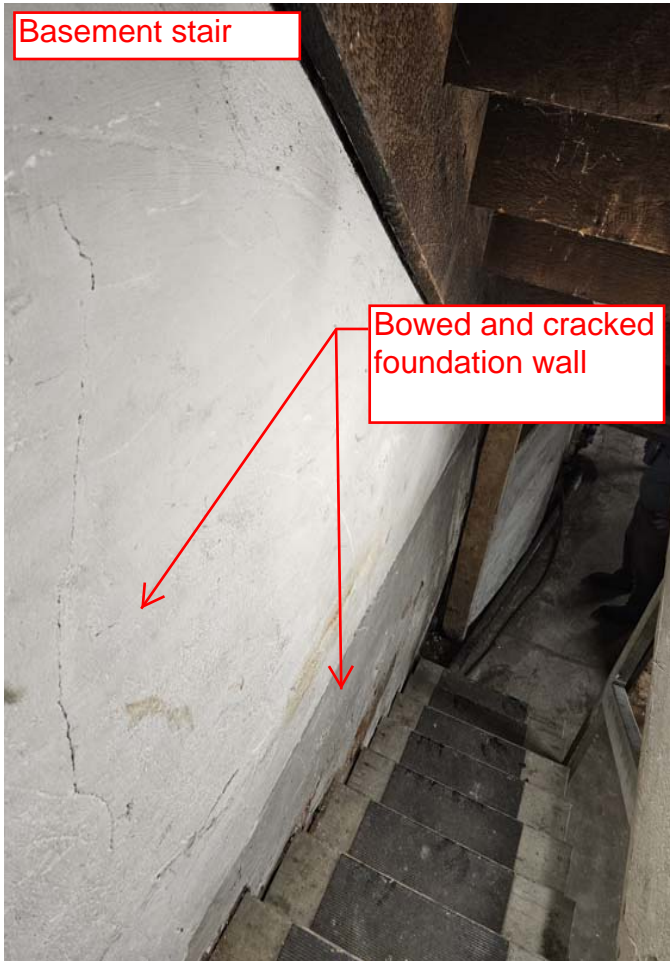
Basement stair

Bowed and cracked foundation wall

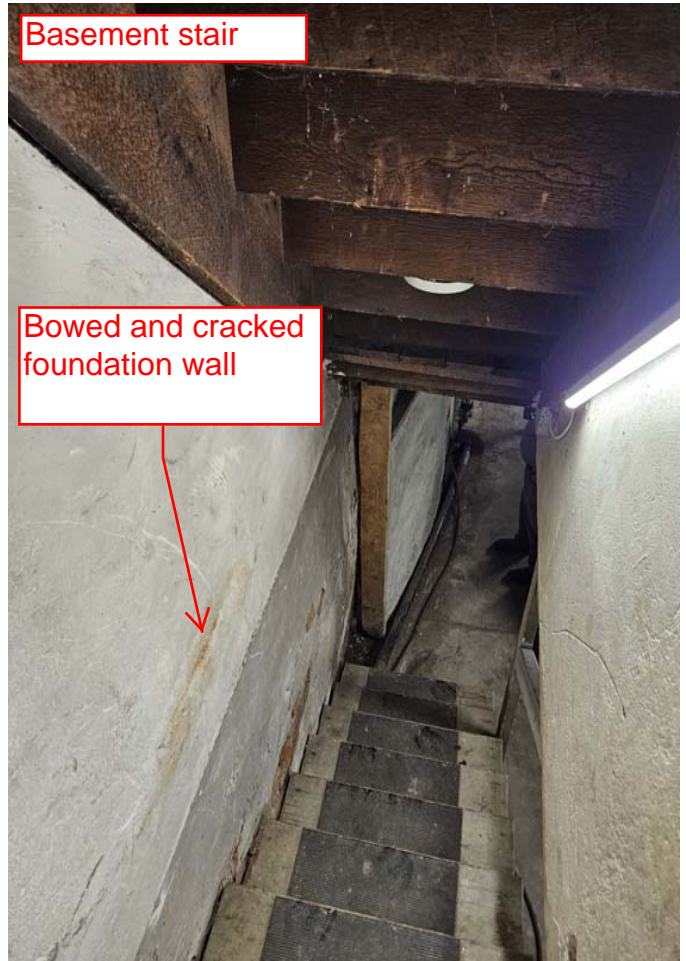
Basement stair

Bowed and cracked foundation wall

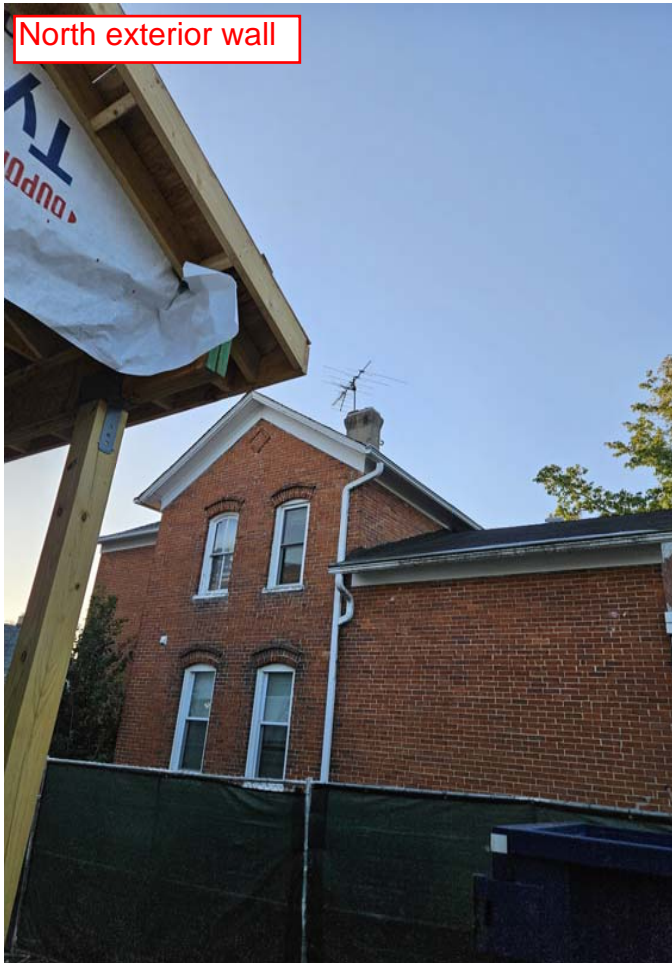
North exterior wall

- The sidewalk along the south side of the house has been removed due to setback issues.
- Exception for a few windows that have been replaced, the remainder of windows, trim, etc. have deteriorated.
- The chimney is cracked and spalled above the roof, likely from water infiltration.
- The wall of the rear addition appears to be sitting on a spread footing. However, the top of the footing is above grade. Likely, there is inadequate frost cover provided.

Deteriorated chimney

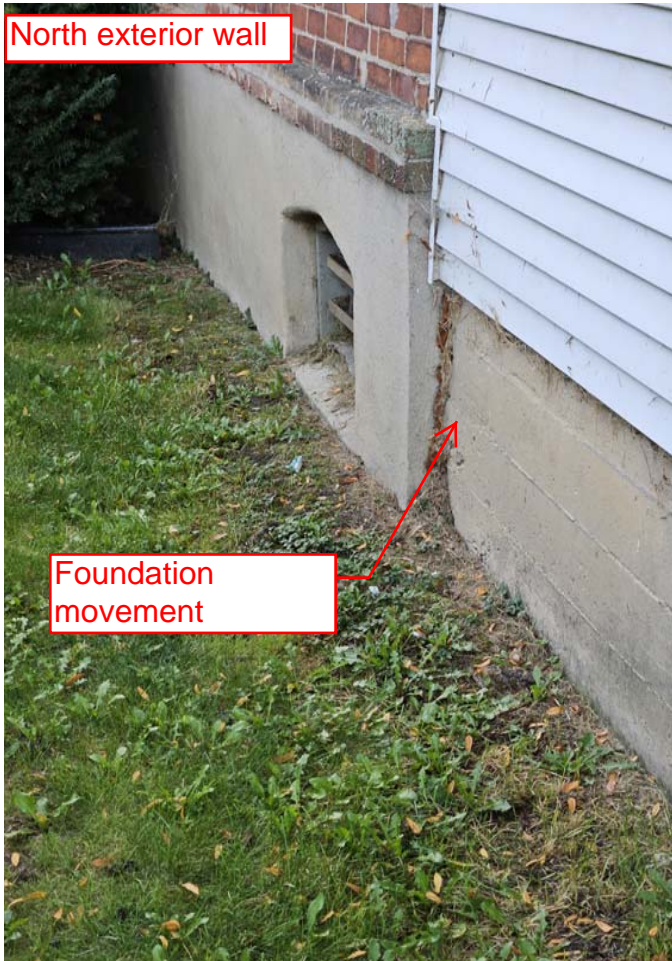
Exposed foundation
