ARLINGTON HEIGHTS POLICE DEPARTMENT FEASIBILITY STUDY

FEASIBILITY STUDY

August 12, 2015
FGM # 14-1933.01

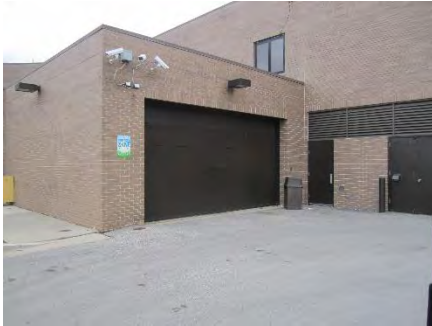
Sally Port Exterior

- **Sally Port:** This is a dedicated secure garage where prisoners are securely brought into the police station. The current sally port is utilized for many different functions, including prisoner transfer, general maintenance and storage of many different items. A sally port is intended to be a dedicated secure space providing a transfer point from a patrol car to a holding area which is safe for both the arresting officer and the arrestee. This is very difficult to achieve when the space is used for other functions.
- **Holding Cells:** The Illinois Department of Corrections governs the design of holding cells. The holding cells within the police station are an older design and do not meet the

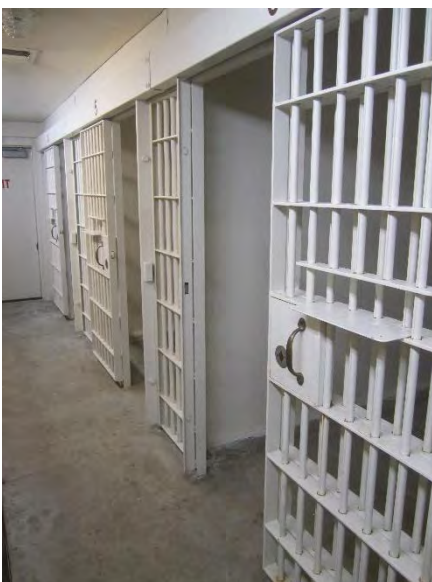
Holding Cells

current requirements. The cells have bars which are not considered to be safe for staff or detainees.

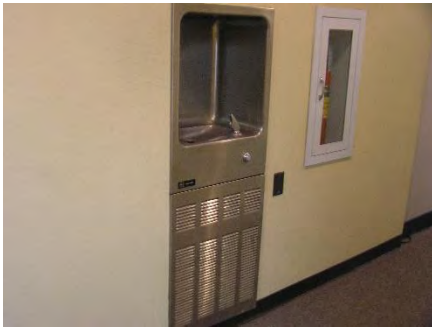
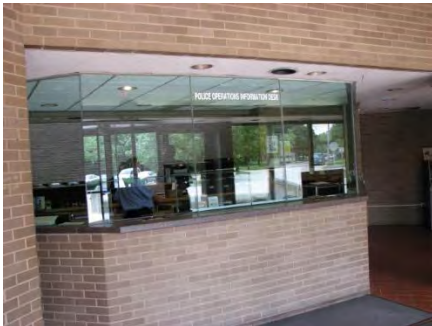
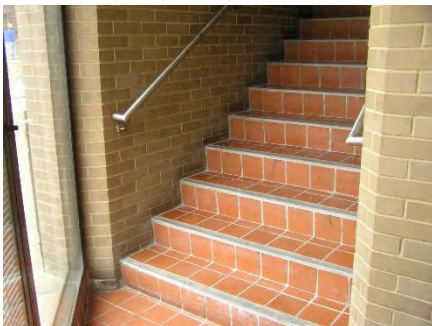
- Some workstations are not handicap accessible.
- Corridor exit width is reduced by storage in the corridor in many cases.
- The three story atrium space is not protected with a smoke evacuation system or with sprinklers.

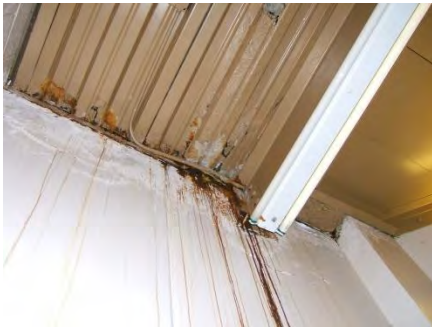
The metal deck below this crack has been corroded due to water infiltration. This area was inspected by a structural engineer in March of 2005.

While not an immediate concern, it was recommended for repair as soon as practical. This item remains a deferred maintenance item.

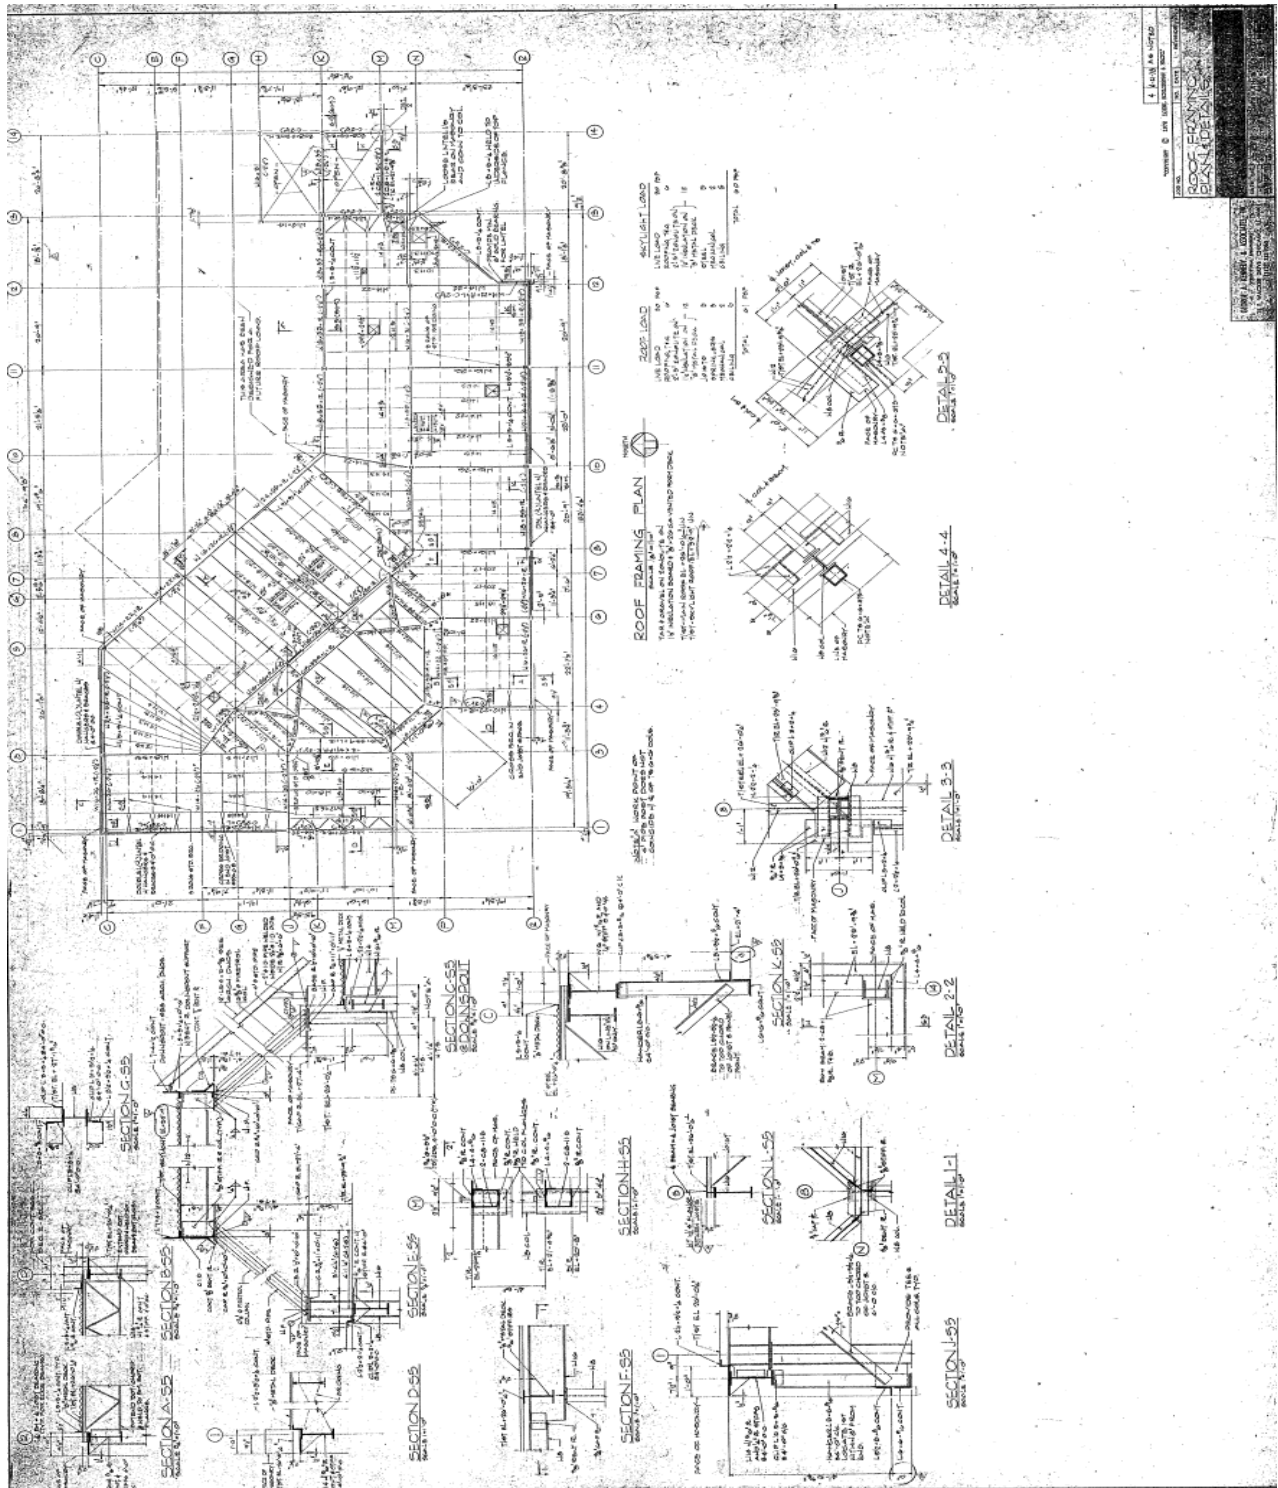
Figure 1

No specific lateral system is detailed on the existing structural drawings. The building is most likely being laterally supported by the combination of interior CMU partitions and the partial rigidity of the beam to column shear connections. See Figure 1.

One option is to bring the structure up to compliance and add reinforced masonry shear walls at various spots in the building. The minimum amount of shear walls required to bring the police station up to code for 2003 IBC is 128 linear feet of 12" CMU. Obviously, this would replace the walls that are currently in those locations, so extensive demolition would be required to replace the masonry and connect it to the steel structure and foundation properly.

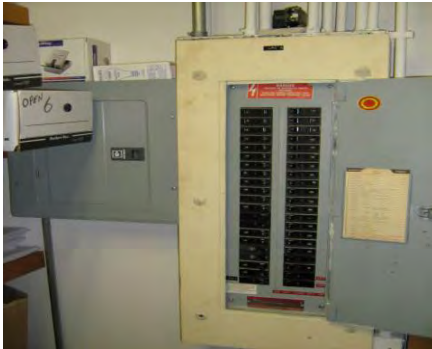
The current installation of the equipment has several code violations and safety issues. National Electric Code requires a minimum of 36" working clearance in front of all electrical equipment. Currently, there is an obstruction in the required working space surrounding the switchboard. Not all switches are properly identified which is also a code violation. The electrical room housing the switchboard is small with a single exit. Current code requirements for this size of equipment requires two exits from the electrical room. In the event that two exits do not exist, code requires significantly greater working clearance in front of all equipment. In addition, the emergency power distribution panel fed by the generator is located in the same room as the normal power service. A failure in either panel could affect the other panel. It is advisable that these panels are located in separate rooms. Replacement of the switchboard and electrical equipment would require a new, properly sized electrical space.
