ALTA ENGINEERING, Ltd.
CONSULTING ENGINEERS

October 4, 2023

Re: 716 N. Dunton - Existing conditions
Arlington Heights, IL
AEL No. 23514.AEL

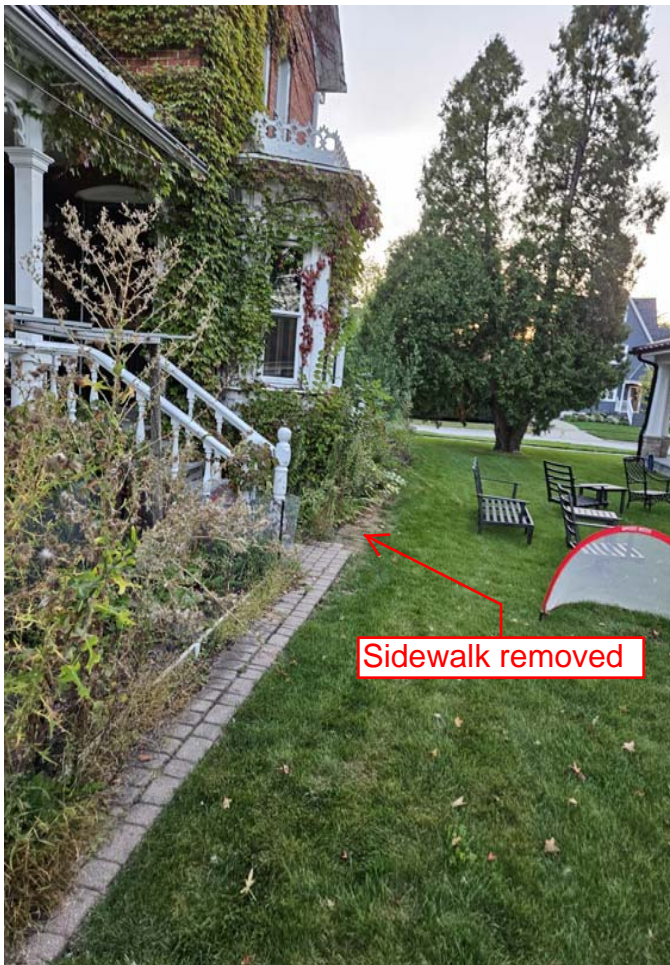
- The sidewalk along the south side of the house has been removed due to setback issues.
- Exception for a few windows that have been replaced, the remainder of windows, trim, etc. have deteriorated.
- The chimney is cracked and spalled above the roof, likely from water infiltration.
- The wall of the rear addition appears to be sitting on a spread footing. However, the top of the footing is above grade. Likely, there is inadequate frost cover provided.

Sidewalk removed
