ARLINGTON HEIGHTS POLICE DEPARTMENT FEASIBILITY STUDY

FEASIBILITY STUDY

August 12, 2015
FGM # 14-1933.01

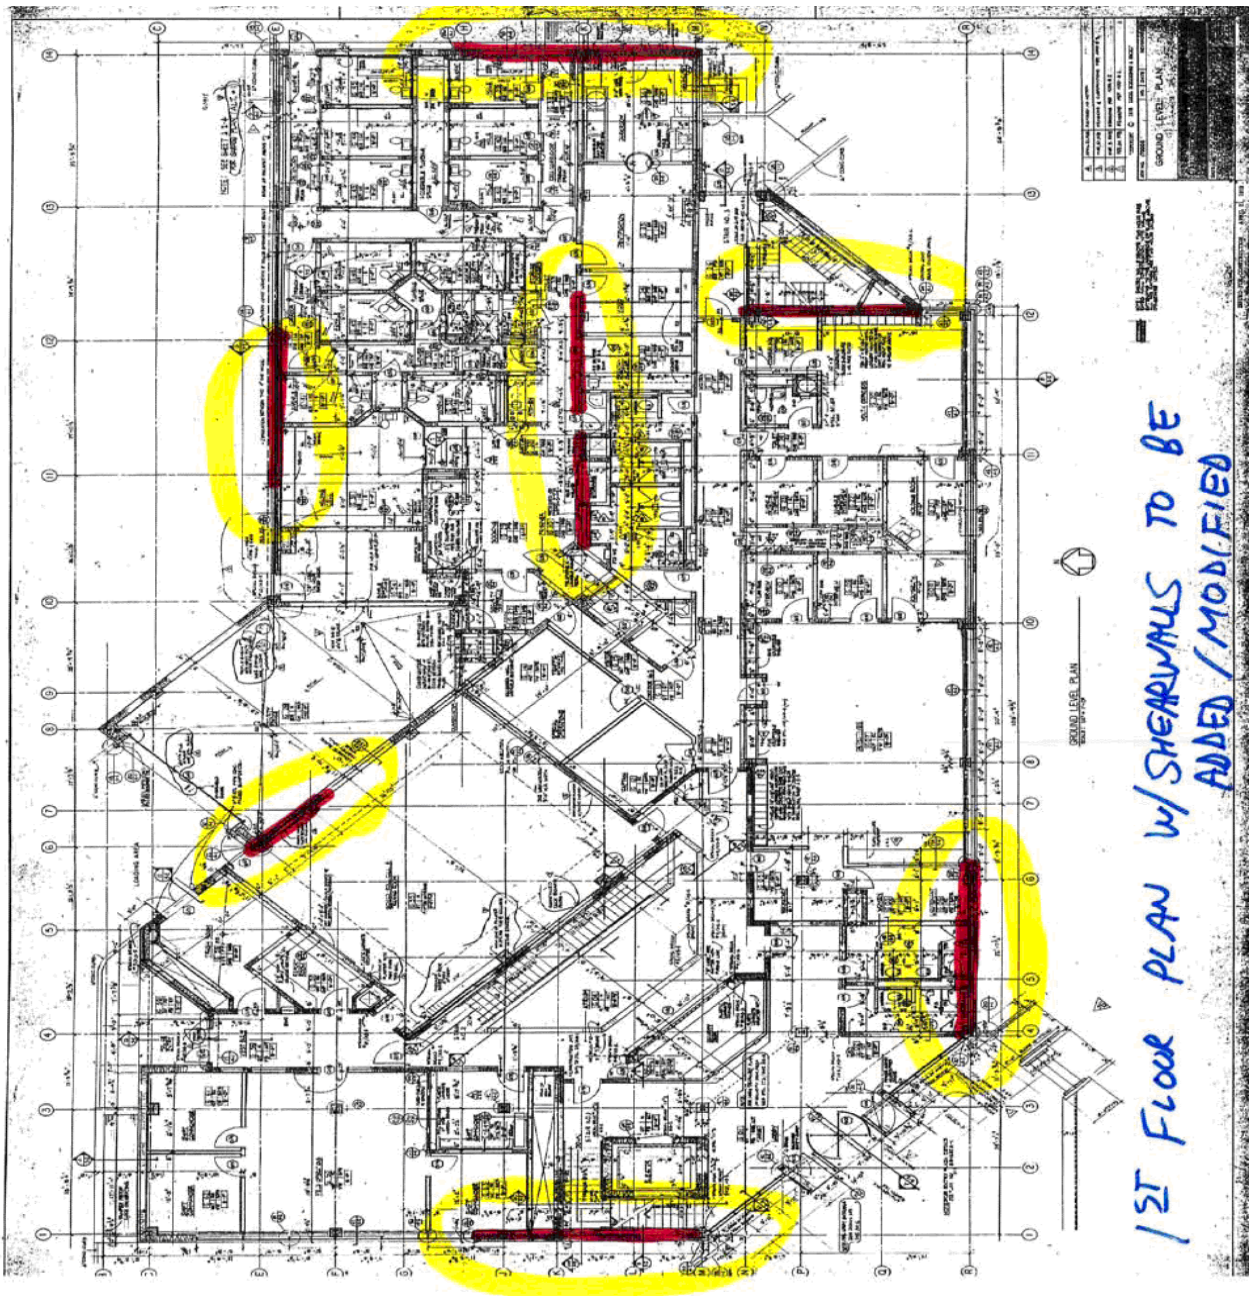
Figure 2

One option is to bring the structure up to compliance and add reinforced masonry shear walls at various spots in the building. The minimum amount of shear walls required to bring the police station up to code for 2003 IBC is 128 linear feet of 12" CMU. Obviously, this would replace the walls that are currently in those locations, so extensive demolition would be required to replace the masonry and connect it to the steel structure and foundation properly.

Highlighted areas illustrate locations where 12" CMU shear walls would need to be added to comply with 2003 IBC. See Figure 2.

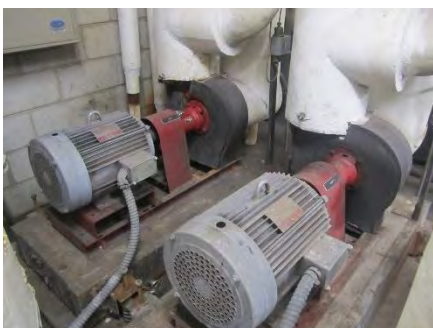
The boilers combine for a total heat output of 4,000 MBH. The four piping systems combine for a connected load of 3,930 MBH. In other words, there is only 70 MBH excess connected capacity built into the size of the boilers. However, this does include the previously mentioned excess capacity designed into the reheat and finned tube piping loops for the garage and second floor expansion. For a building of this size, approximately 45,000 square feet, the estimated heating required would be 2,200 MBH. Therefore in order to provide redundancy, if a boiler were to require maintenance, the boiler sizes are appropriate, however do not allow for much building expansion while maintaining redundancy. In addition, with the exception of the heating/chilled water loop, none of the piping systems incorporate pump redundancy.

According to the American Society of Heating, Refrigeration, and Air-Conditioning Engineers (ASHRAE) HVAC Applications Handbook, the average life expectancy for a flexible water tube boiler is approximately 25 years. Average life expectancy is the median amount of time for units that have been replaced. Others view this as the age at which maintaining the unit is cost prohibitive compared to replacing it. The average life expectancy for base mounted pumps is 20 years and inline (pipe mounted) pumps are 10 years. The Police Station was built in 1978;

therefore, the heating system equipment is almost 30 years old which is past the average service life according to research done by ASHRAE.

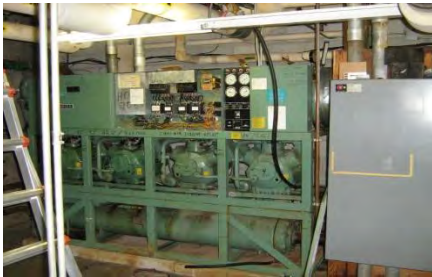
The combined heating/cooling water pipe loop reduces the Owner's ability to provide consistent comfort for the building's occupants over the entire year. The heating/cooling water system can only provide heating or cooling, not both. Once the maintenance staff has changed over the system (from heating to cooling in the spring and cooling to heating in the fall) the system will not be changed back until the next season. Therefore, if there are unseasonable days, the system does not have the ability to properly condition the building and the occupants will be uncomfortable. Significant piping and system modifications would be required to fix this shortcoming. The propping open of doors and windows is a "weak link" and poses a security risk.

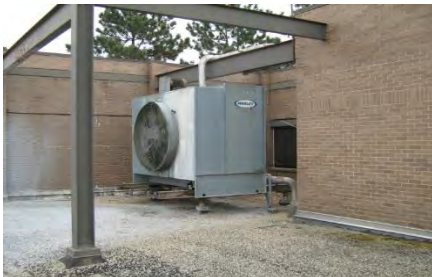
The cooling system consists of one chiller located in the lower level mechanical room, one cooling tower located on the roof, two heating/cooling water pumps, and one condenser water pump. The existing chiller is 155 tons and provides chilled water for the three air handling units and a couple of fan coil units.

According to the American Society of Heating, Refrigeration, and Air-Conditioning Engineers (ASHRAE) HVAC Applications Handbook, the average life expectancy for a packaged chiller is approximately 20 years and for a steel cooling tower is 20 years. The average life expectancy for base mounted pumps is 20 years. The Police Station was built in 1978; therefore, the chilled water equipment is almost 30 years old; past the average service life according to research done by ASHRAE.

The chiller, cooling tower, and piping system was not sized with any excess capacity. The only redundancy in the system is found in the heating/chilled water pumps. For a new building this size (approximately 45,000 square feet) under today's ventilation codes, it would be estimated that a chilled water system would need to be approximately 200 tons. The installed system at 155 tons does not offer any capacity for expansion.

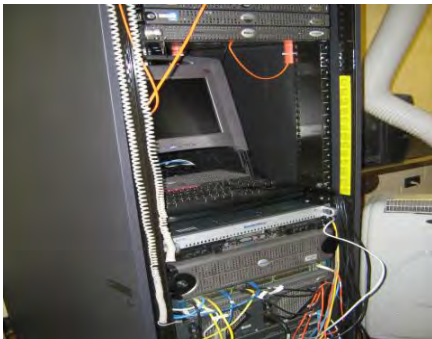
It appears the intent of the original installation was to provide a 10/100 MB solution. The cabling infrastructure consists of Category 5 copper station cable and fiber optic backbone cable. All cable throughout the facility is installed open and improperly supported or secured in many areas.

Because the building does not have formal telecom rooms, the cable distribution architecture does not meet industry standards. In addition, there is no vertical pathway to implement a proper system. Many termination points and equipment racks share space with storage rooms and janitor closets. An equipment rack on the third floor serves as the Main Cross Connect; however, there is inadequate cooling. This lack of cooling will dramatically affect the life expectancy of the active components in this rack and in the various other freestanding racks located in the facility.

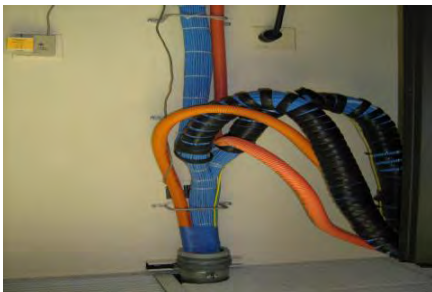
Fiber optic distribution on the lower level is directly below a coolant line in the electrical room. An incoming service room is adjacent and contains a large wall field. Space for expansion is limited.

Expansion of the network cabling system would be prohibitive as there are no formal telecommunication rooms. As a result, basic standards for a universal cabling system such as grounding and cable management are non-existent. In addition, the bandwidth capacity of the existing infrastructure will not be able to support additional systems or services.

The recommendation would be to implement a universal cabling system consisting of Category 6 cable terminated on modular patch panels supporting network speeds up to one Gigabit. The universal cabling concept allows staff the flexibility to assign any service to any cable as needed simply by installing a patch cord in the telecommunication room. This also minimizes the amount of cables needed at each individual workstation.
